Liskeard Town Council Tree Survey and Management Report.

TREE SURVEY AND MANAGEMENT REPORT

Instructed by:	Jacqui Orange Facilities Manager Liskeard Town Council 3-5 West Street Liskeard PL14 6BW
Compiled by;	Bruce Macfarlane, MArbor A, P Dip Arb (RFS)
Date:	14 th November 2022
Report ref:	CTC141122HS

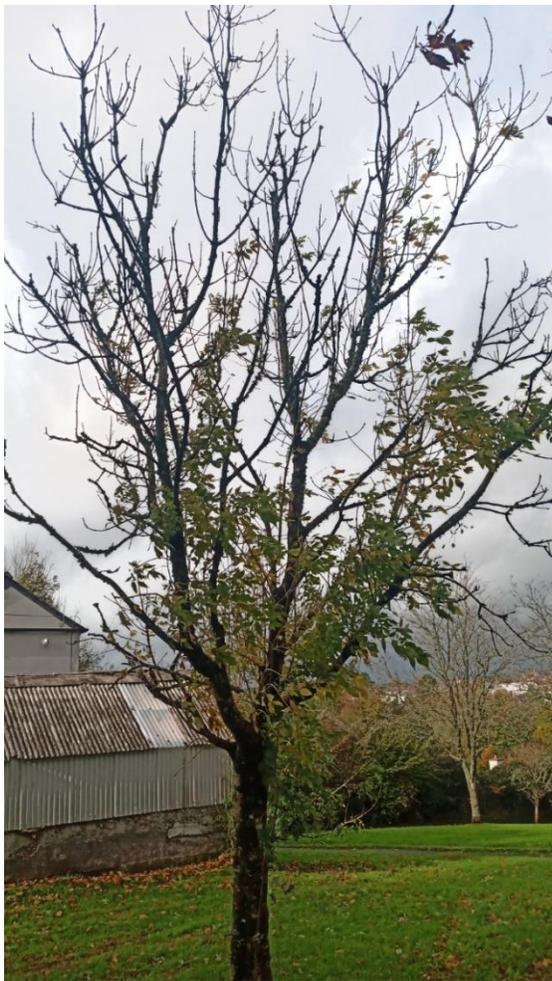
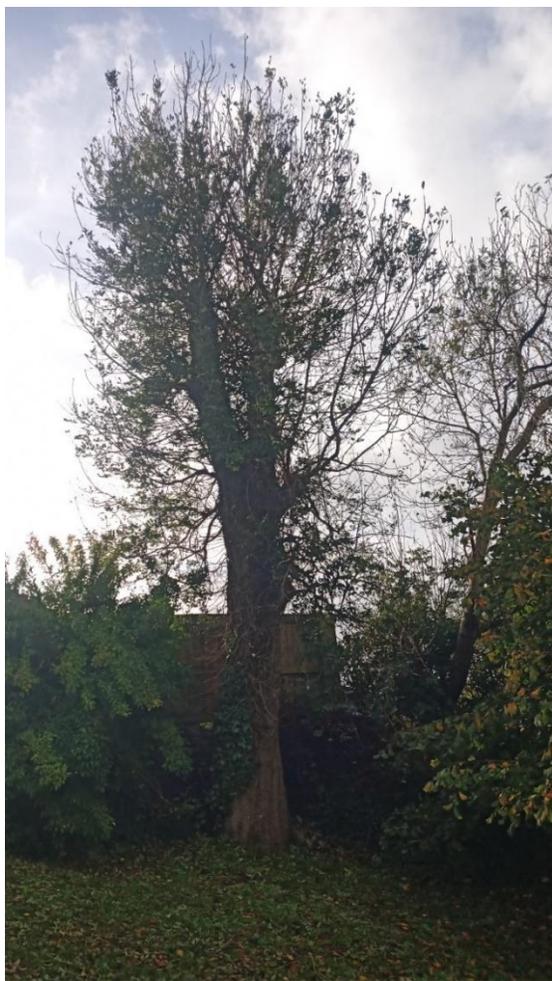
Thorn Park contains Ash which shows signs of Ash dieback, the trees should be regularly inspected during the summer to monitor the extent of this fungal infections (symptoms include dead leaves and twigs and possible lesions on stems).

Photo 1&2: Ash 916 & 920 showing signs of Ash dieback disease.

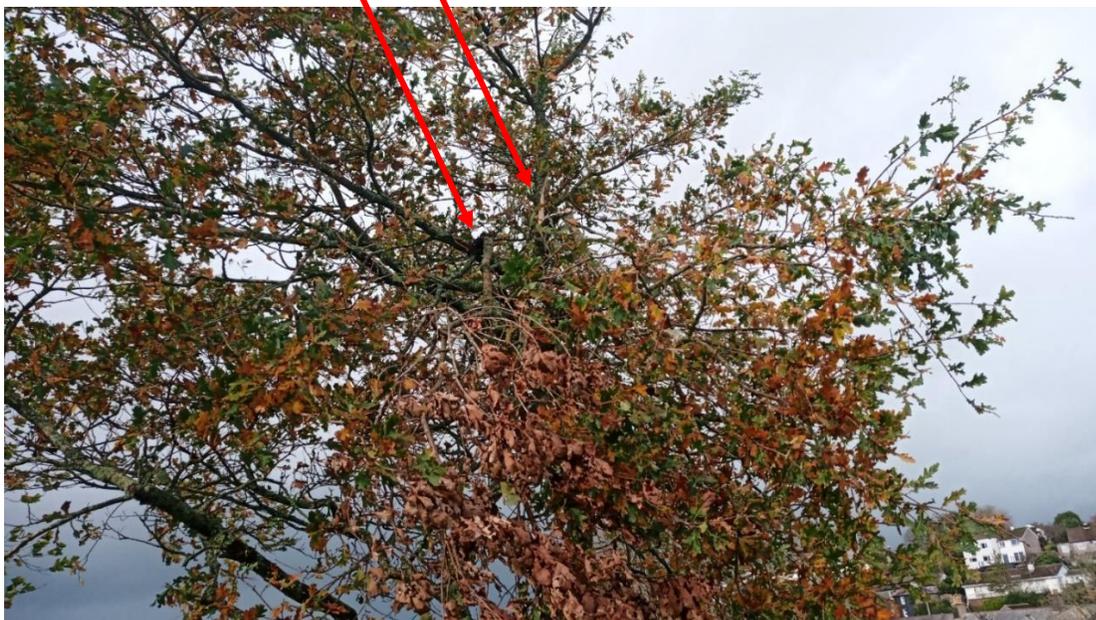
Photo3: Oak 327 with two broken branches

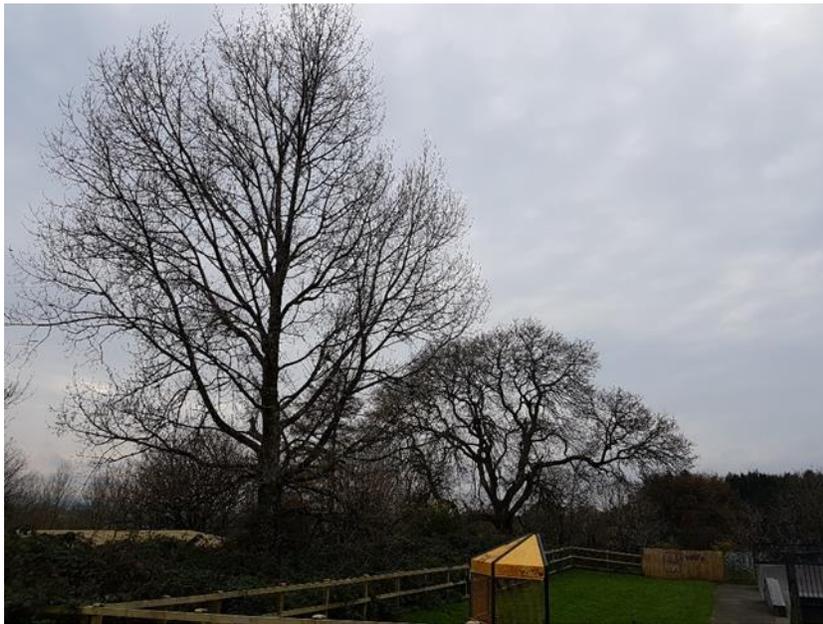
The tree is generally in good condition and has never received any pruning. This species of poplar is prone to losing branches as they mature due to their fast growing nature resulting in a weaker wood and branch unions. Should branches start to fail It is recommended that the tree receives a total crown reduction.

Photo1: Hybrid black poplar in area of scrub to side of Rapsons Field

Tree	Condition	Works	Time Frame (Months)
913 Hybrid poplar	Large mature tree one previous branch breakage	No works at this time	N/A

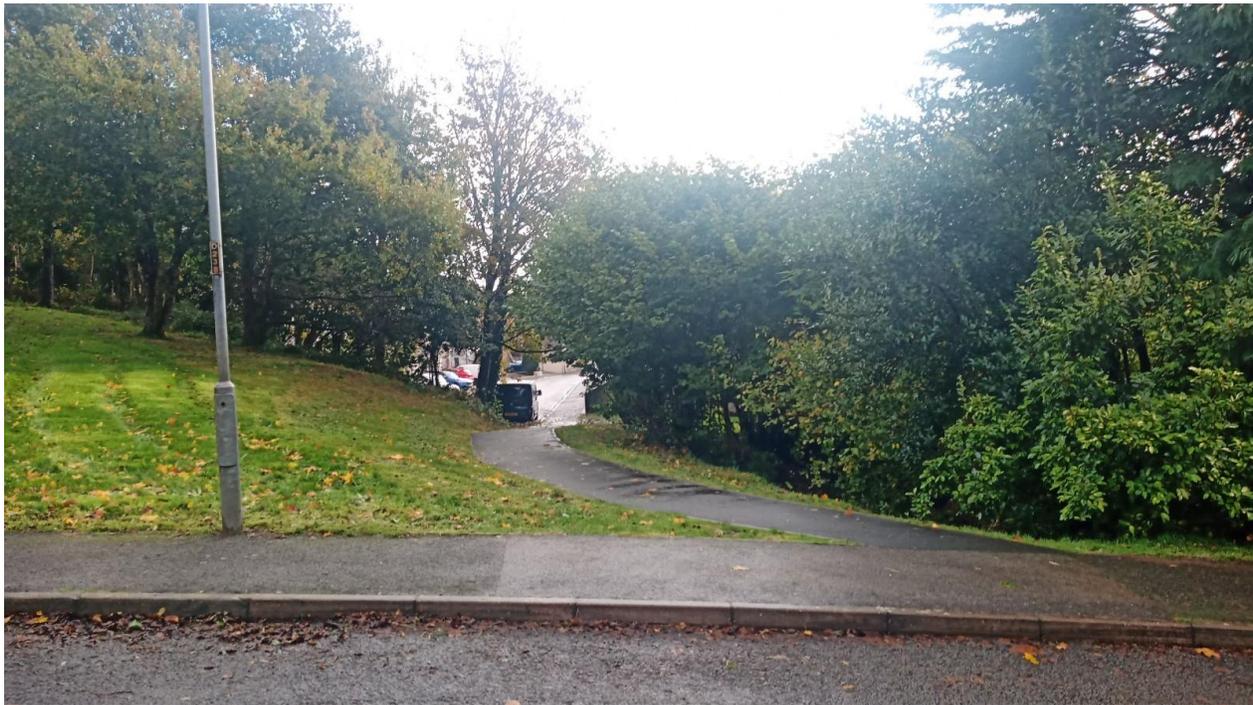
Photo 1: Sloping site with hawthorn to the right and oak, sycamore and ash to the left of the path.

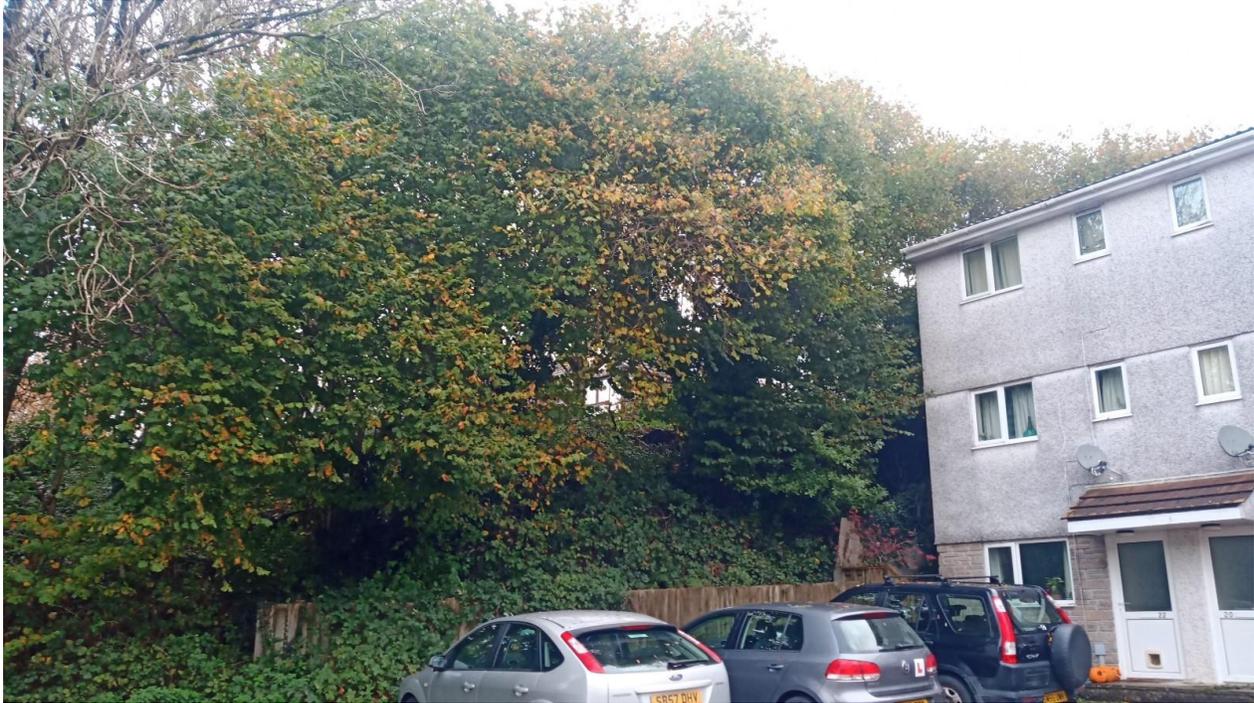
Photo 2: Hazel overhanging parking area and property of neighbouring cul-de-sac

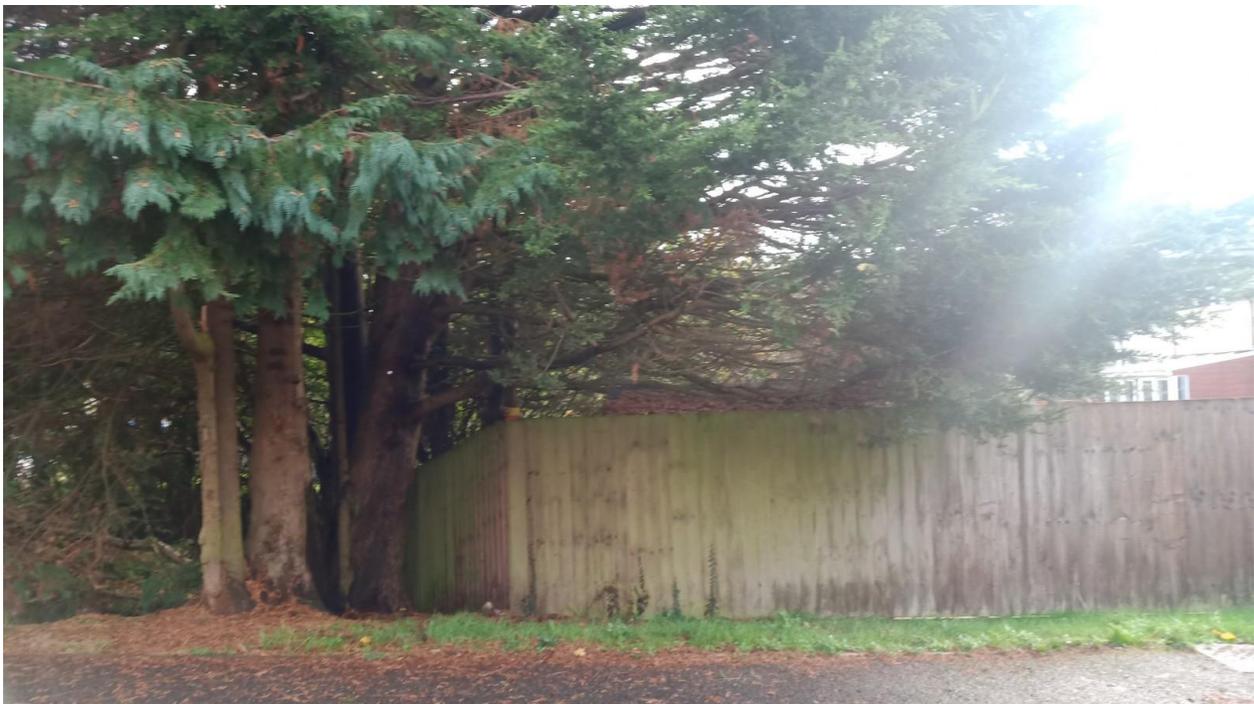
no risk, clumps close to footpath may require cutting back in summer, slightly overhang the neighbouring properties		
T322 Lawson cypress & Leyland cypress	Group of five Lawson and leylandii Cypress stems branches low over footpath and neighbouring property.	recommend crown lifting over footpath and off of neighbours fence line and garden shed	6mths

Photo 3: Leyland and Lawson cypress low over path and neighbouring garden fence and shed
