## 9. Guildhall – Fire Alarm System and Ventilation Report for Facilities Committee – 16.11.2021

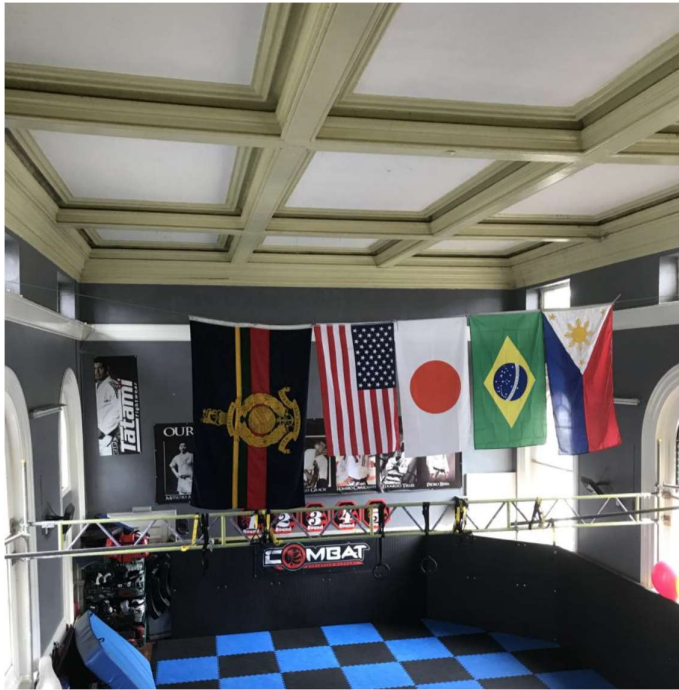
Image of the ceiling taken in September 2017:

In addition, there is concern over the condition of the ceiling and walls. A structural engineer carried out an inspection of the ceiling in 2017 following a small section of ceiling falling. The report found the plasterwork appeared to be in relatively good condition and that there were no signs of significant cracking. However, the two photographs below illustrate the condition of the ceiling in September 2017 compared to June 2021. The now extensive black mould growth also extends down the walls, particularly on the north wall to approx. 3m of the floor height and will start to affect the structure of the building.
