QUINQUENNIAL BUILDING SURVEY

**LISKEARD GUILDHALL,
13 PIKE STREET, LISKEARD,
CORNWALL, PL14 3JE**

**DATE OF INSPECTION:-
Thursday 11th July 2019**

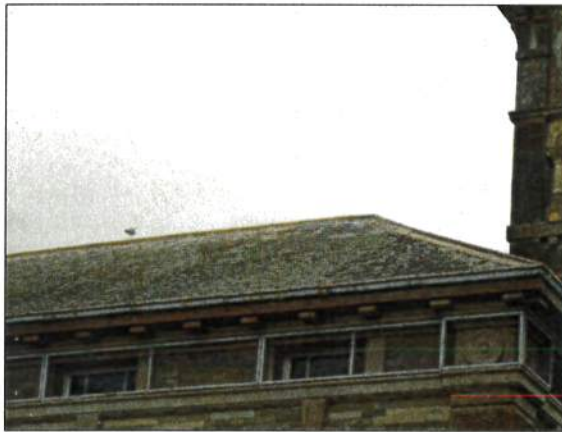
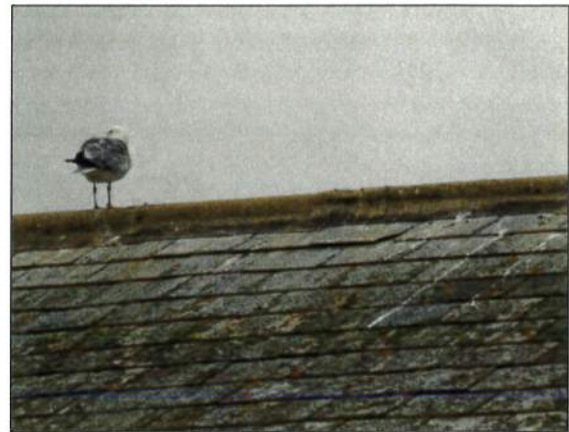
There is a cut slate roof hip style finish to the main roof. This was generally found to be in a satisfactory state of repair although three slates have been clipped back to the west while there are two slipping slates to the east.

There are large gaps to the south-western corner between the slate joints although no major problems are envisaged.

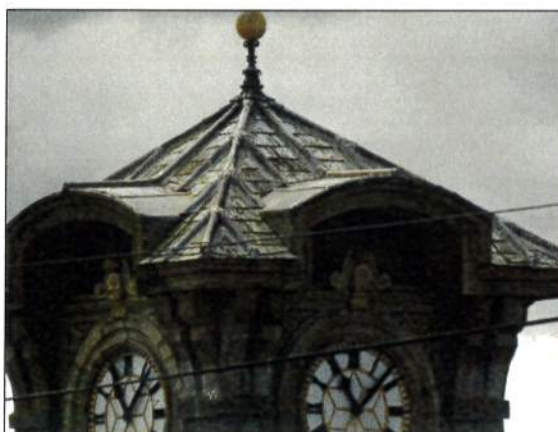
Externally, there is a sloping hip style roof cover to the clock tower. There are lead expansion joints and hip ends which were found to be in good repair.

There are swept head finishes to part of the roof covering with lead finishes that were also found to be in good repair.

Feature ball style weather vane attached to the top of the clock tower in good repair.

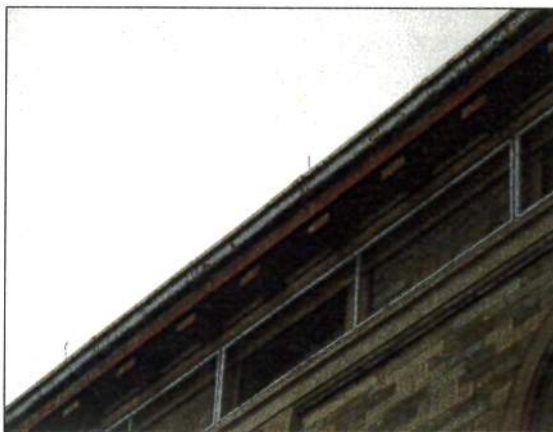
Metal rainwater gutter to the east – corroding slightly and joints also leaking slightly. Leaking joints need to be suitably sealed. The rainwater gutter generally requires cleaning.

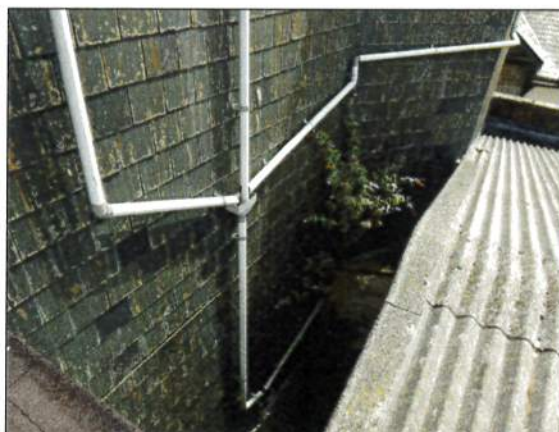
There is a half round PVC rainwater gutter to the south which discharges to three downpipes emptying to catch buckets and then to an underground drainage system.

The guttering to the south was generally found to be in good repair although we suspect that it does not conform to Listed Building requirements.

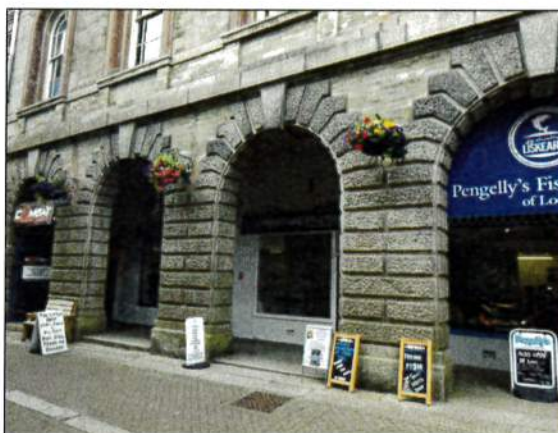
Stonework softening and delaminating slightly but generally sound.

Five feature archways with granite lintels and quoins – joints to some of the granite cracking slightly – but generally the archways were found to be in good repair.

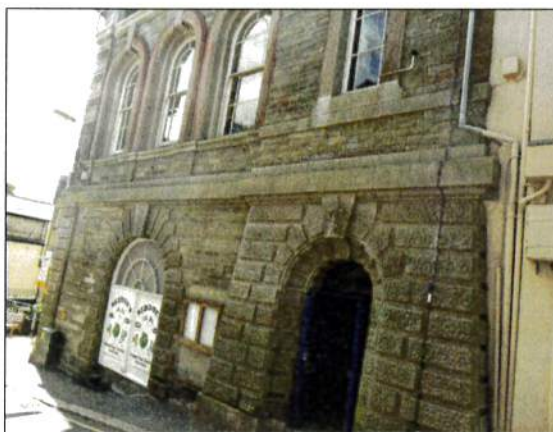
Feature stone and granite walling approximately 650mm thick.

Feature granite archways to two ground floor openings. Granite work generally sound with a feature granite buttress adjoining the main entrance door. However, the granite keystone above the entrance door was noted to be slightly cracked.

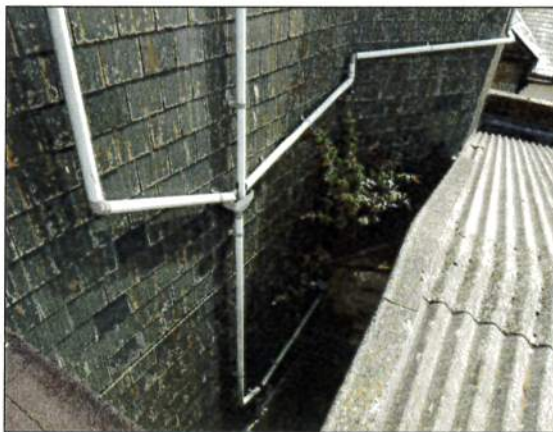
There is a slate hung finish to this elevation which represents a good damp proof membrane. However, there are missing, broken and slipping slates that need to be replaced.

Some slates have been clipped back to the hanging work.

There is a buddleia adjoining this wall that really needs to be removed.

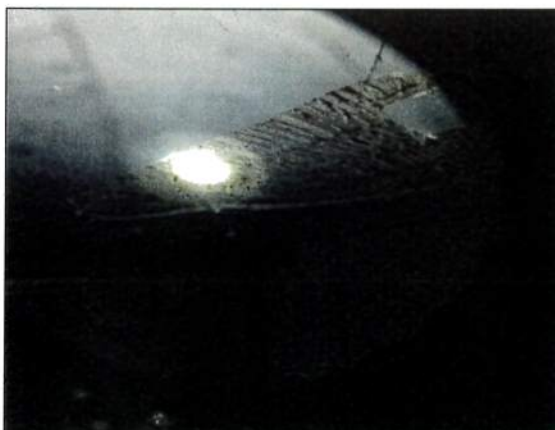
Part lath and plaster and part plasterboard sheet ceiling above. Lath and plaster ceiling badly damaged and in need of repair. The plasterboard sheet ceiling is sagging slightly.

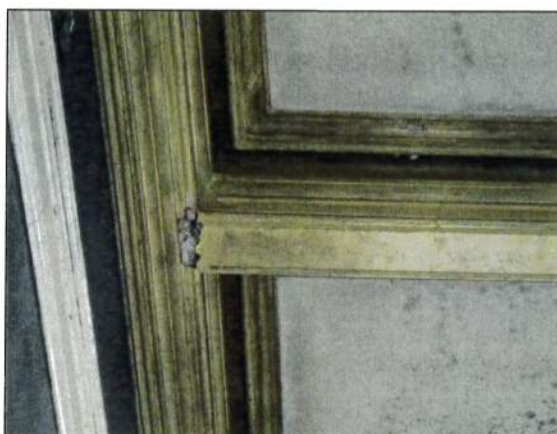
Very high feature panelled lath and plaster ceiling to the Gym – condensation mould clearly visible – plasterwork slightly loose and cracked – but otherwise satisfactory although repairs have been completed in the past. While this ceiling surface is satisfactory at present, you should bear in mind that lath and plaster ceilings deteriorate with age and future replacement may be necessary. As the area below is used very extensively for a Gym, the fitment of some safety netting for the long-term future might be a worthy consideration.
