**Asbestos Management Survey
on behalf of
Liskeard Town Council**

**at
The Guildhall
Pike Street,
Liskeard.**

COMPILED BY: PDavies Consultancy Ltd 1st Issue DATE: 8th October 2017

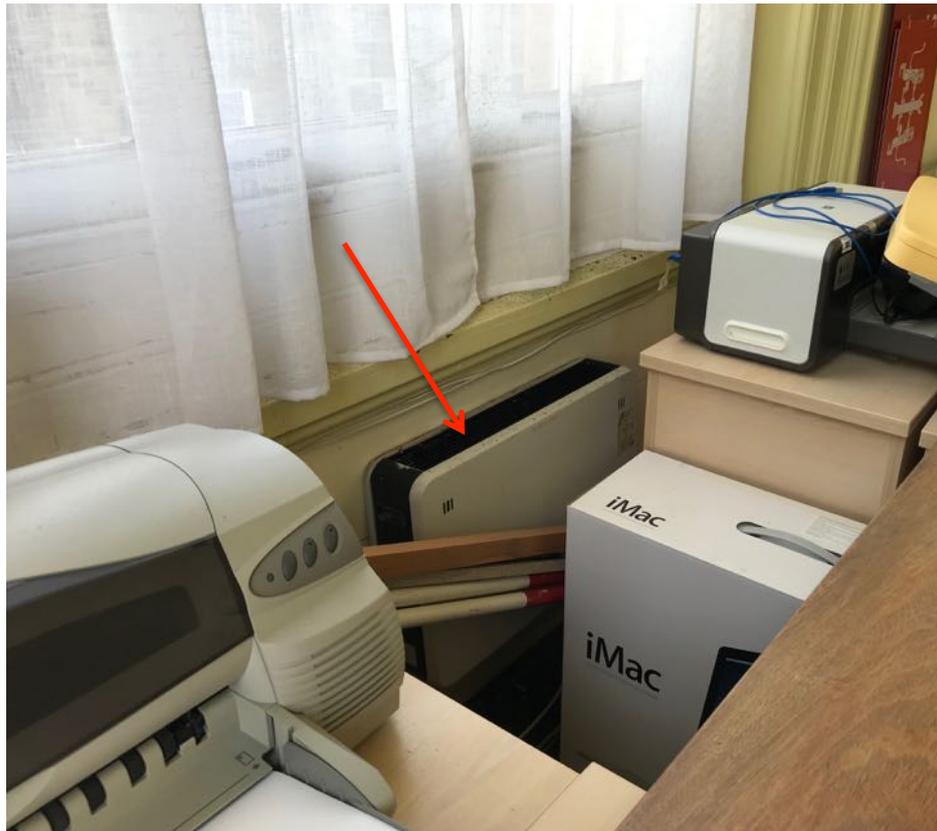
Photo 01

Plan Ref	Floor	Room	Location	Material	Quantity	Photo No.	Sampled	Condition	Risk	Comments
FF01	First	Small Office	Night Storage Heater	No Access Within	X1	01	Presumed	Good	Very Low	No Access. Refer to Recommendations
FF01	First	Small Office	Door Handle	Bakelite	X1	02	Presumed	Good	Very Low	Monitor. Refer to Recommendations
FF01	First	Small Office	Wall Vent	No Access Within	X1		Presumed	Good	Very Low	No Access. Refer to Recommendations
FF01	First	Small Office	Door Lining	Board		03	PD22091 7/01			No Asbestos Detected In Sample (N.A.D.I.S.) No Further Action Required
FF02	First	Passage	Door Lining	Board			Ref: PD22091 7/01			N.A.D.I.S. No Further Action Required
FF02	First	Passage	Fire Place	No Access Within	Unknown		Presumed	Good	Very Low	No Access. Refer to Recommendations
FF02	First	Passage	Fuse Boxes	No Access Within	X2	04	Presumed	Good	Very Low	Monitor. Refer to Recommendations
FF02	First	Passage	Junction Boxes & Switch	Bakelite	X5	05	Presumed	Good	Very Low	Monitor. Refer to Recommendations

No action is necessary unless the heater is damaged or requires removal. Please be aware of the asbestos material and consult an Asbestos Specialist prior to removal. Fully controlled conditions apply to the removal of this item.

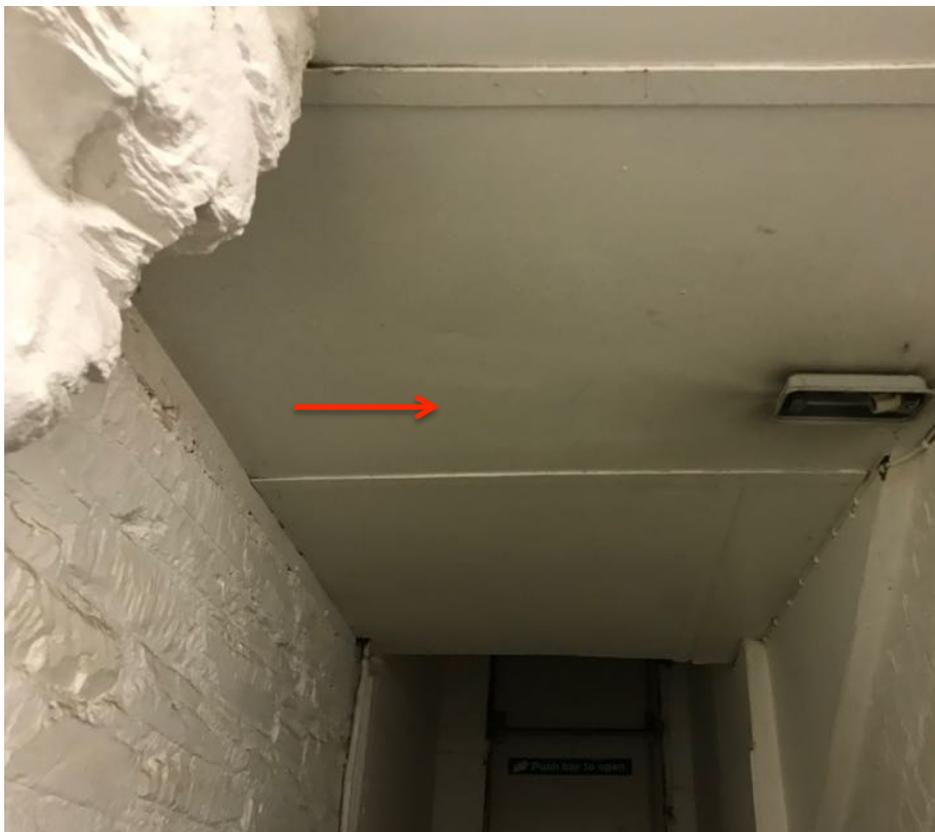
Photo 08

-	Shops	Beddoes Store	Junction Boxes	Bakelite	X3		Presumed	Good	Very Low	Monitor. Refer to Recommendations
-	Shops	Beddoes Store	Ceilings & Wall Linings to side entrance	Board		08	Ref: PD22091 7/01			N.A.D.I.S. No Further Action Required

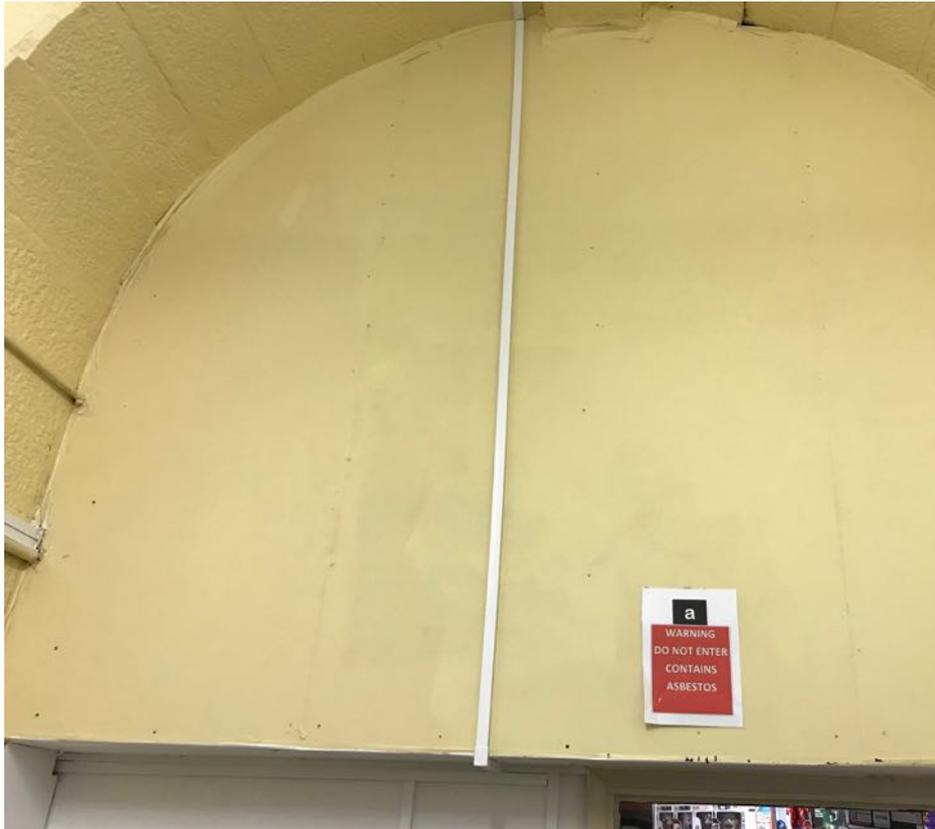
Photo 09

-	Shops	Fish Shop	Suspended Ceiling Tiles	No Access Within	Unknown		Presumed	Good	Very Low	No Access. Refer to Recommendations
-	Shops	Toy Store	Suspended Ceiling Tiles	No Access Within-Previously identified as containing ACM's	Unknown	09	Presumed	Good	Very Low	No Access. Refer to Recommendations

- The ceiling void above the toy store has been previously identified as containing asbestos and as the store was in use at the time of the inspection, the area was not inspected. It has been labelled externally and it is strongly recommended that prior to commencing works on the area, the area is closed and a competent person inspects the area. In its current position it causes no risk as it is sealed above the suspended ceiling tiles. The ceiling void above the fish shop should also be presumed to have some sort of ACM present as it is adjacent to the positively identified area and it was again above a live working area and so deemed unsafe to inspect the area for the occupants.

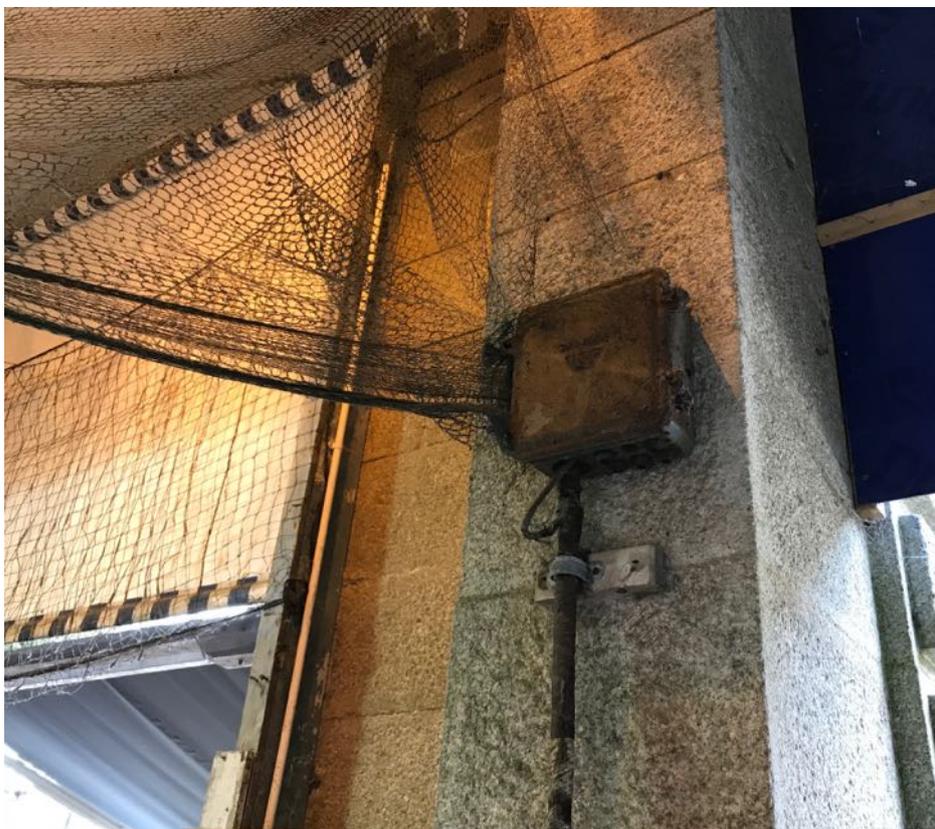
Photo 10

-	Shops	Toy Store	Wall Cladding	No Access Within	Unknown		Presumed	Good	Very Low	No Access. Refer to Recommendations
-	Shops	Walk Way	Fuse Box	No Access Within	X1	10	Presumed	Good	Very Low	No Access. Refer to Recommendations

-	Shops	Walk Way	Mains Cable Wrap	Bitumen Textile	2Lm	10	Presumed	Good	Very Low	Monitor. Refer to Recommendations

- The Mains cable wrap could not be sampled at the time of the inspection as all services were live. Visually similar items have previously been positively identified and so have been presumed in this report. The material if found to be present is classed as very low grade, very low risk and non licensable and it is recommended that it remains insitu and monitored.
