Lamellion to Liskeard Community College

Pedestrian Route Assessment

PRA - EDG0529-251

EDG0529-251 Lamellion to Liskeard School and Community College

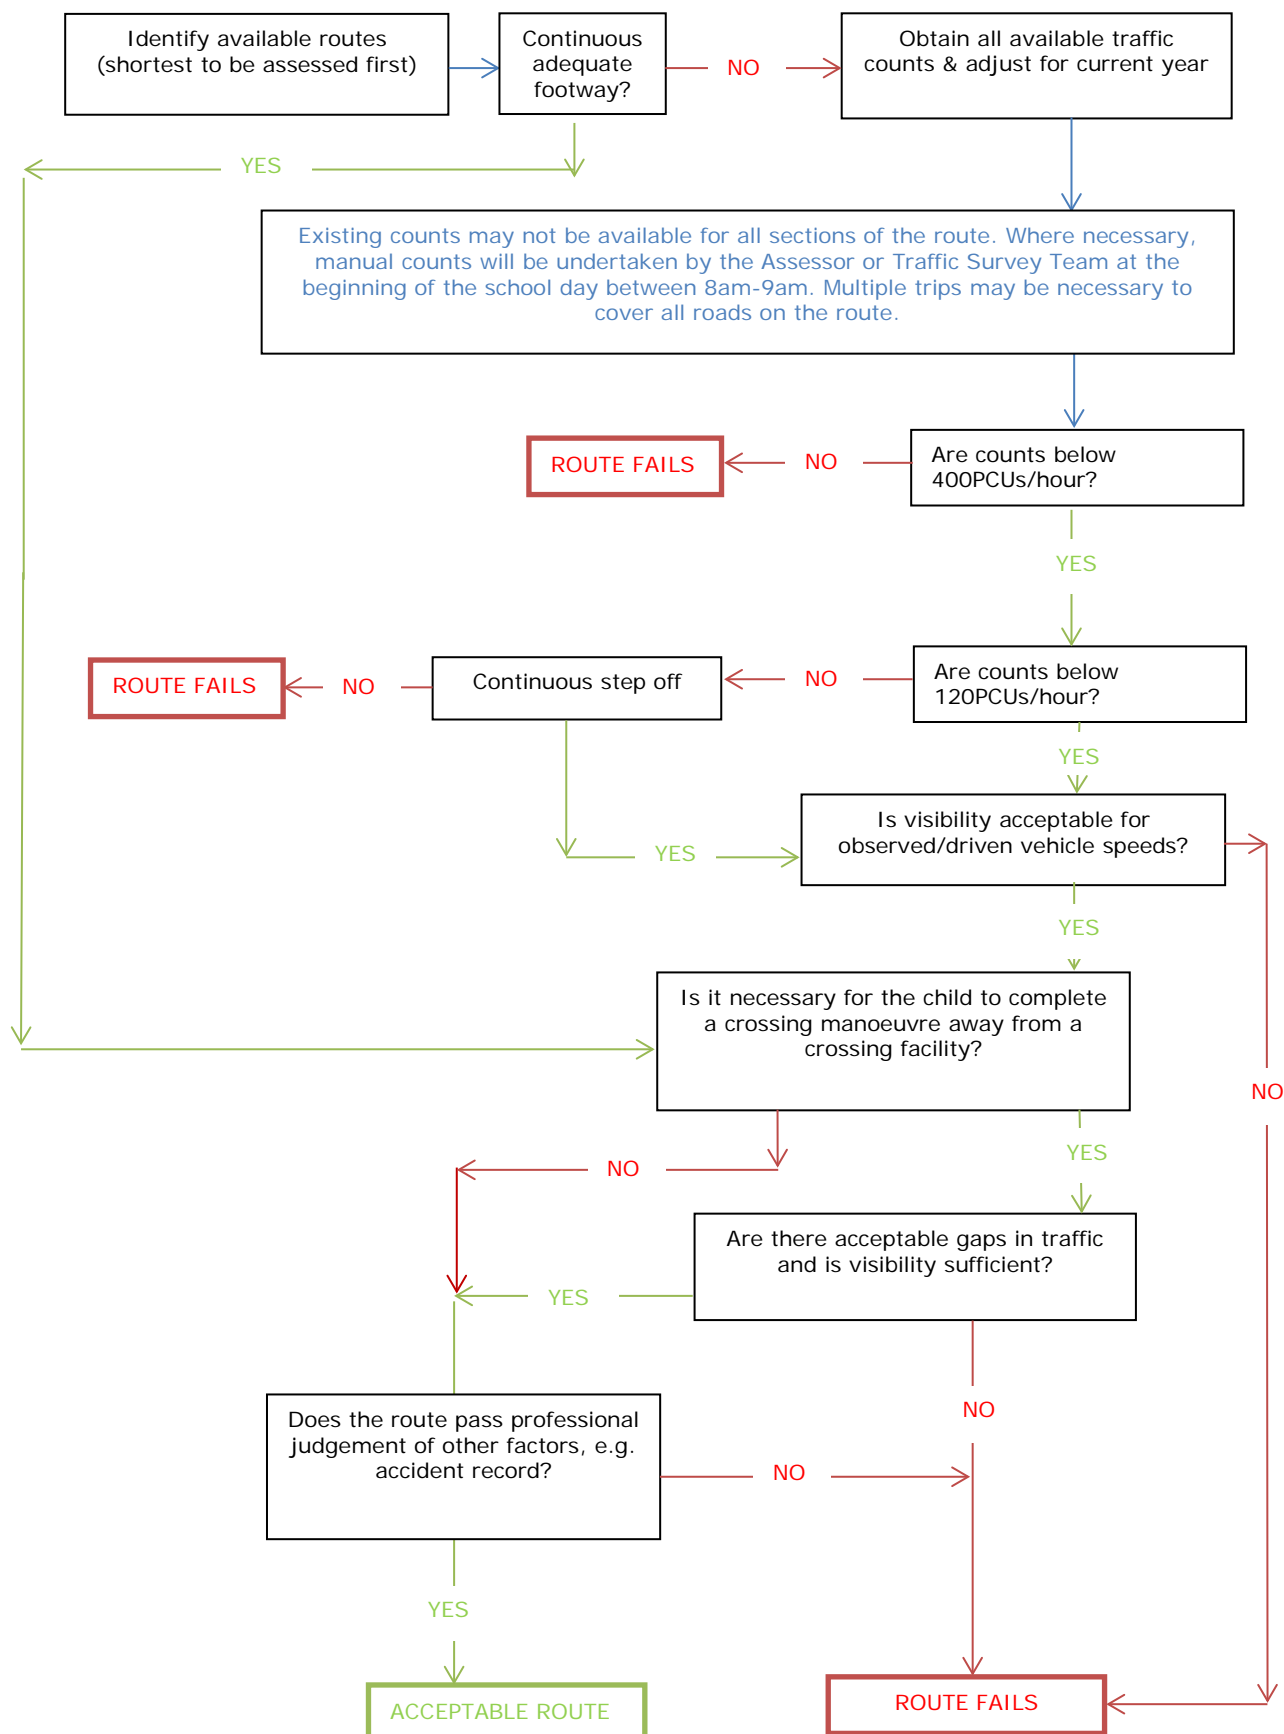
The Assessment Procedure

The flowchart below summarises the assessment procedure which will be undertaken to determine a route's suitability for school pedestrian use. Definitions and further explanation of the criteria used can be found in the 'Pedestrian Route Assessments – Walked Routes to School' Policy.

A summary flow chart is included at the end of this report. The procedure is based upon national guidelines for the assessment of walked routes to school, published by Road Safety GB. The assessments are undertaken by the Engineering Design Group, CORMAC Solutions Ltd. It must be emphasised that no route can ever be entirely safe or free from hazards; the assessment concentrates on estimating the degree of risk associated with a route.

The route is assessed against the key questions listed in section 2 above. The flow chart included in this report, shows the process of assessment and any points at which routes would fail.
