QUINQUENNIAL BUILDING SURVEY

**LISKEARD GUILDHALL,
13 PIKE STREET, LISKEARD,
CORNWALL, PL14 3JE**

**DATE OF INSPECTION:-
Thursday 11th July 2019**

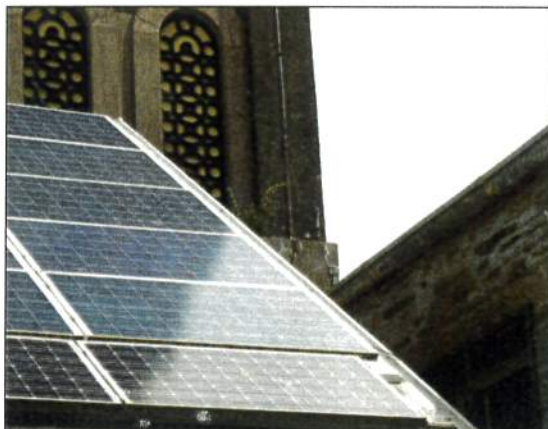
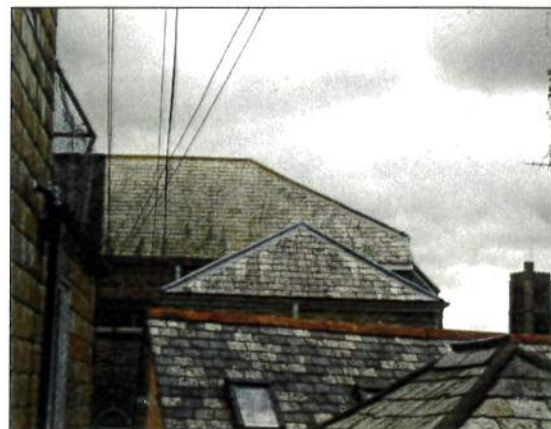
There is an awkward valley gutter between the western side roof cover and clock tower that could not be inspected. Due to the nature of the construction, we suspect that problems are likely to be experienced unless the valley gutter is inspected and cleaned on a regular basis.

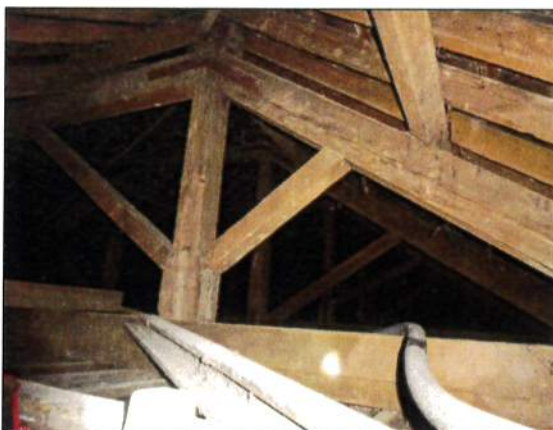
Main Gym Roof Space Area

Access to this roof space area is somewhat difficult from the rear Landing. A long ladder is required. While a ladder was made available, it was still difficult for us to get complete access.

The roof space area was found to be empty at the time of our inspection.

No light, ladder or flooring to this roof space area.

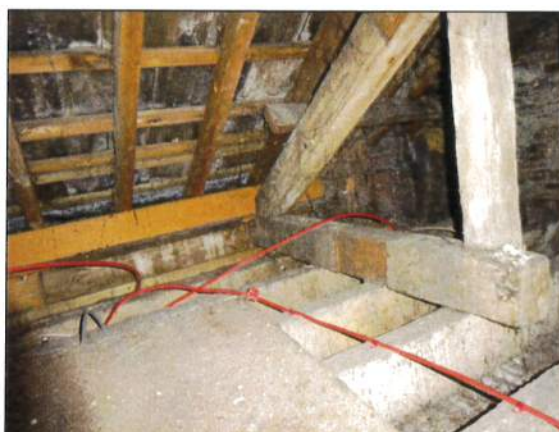
Rear Passageway Roof Space Area

There is an access hatch to this area from the passageway.

No light, ladder or flooring to this roof space area.

Again no insulation in the roof space area.

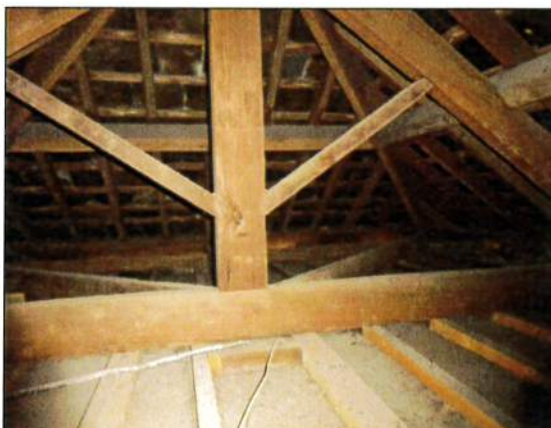
Gym Store Roof Space Area

From the gym store an adequate hatchway to the roof space area.

No light, ladder or flooring in situ.

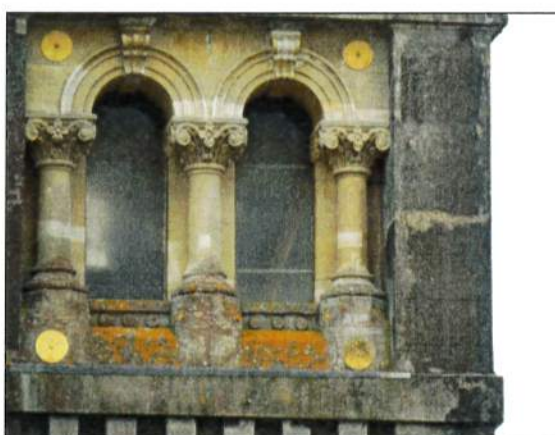
While minor plasterwork cracks noted and tie beams have been inserted into the Clock Tower, we found no evidence of any structural movement to give any reason for concern within the immediate future.

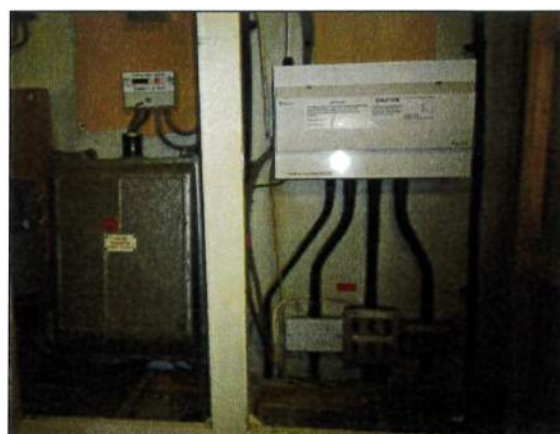
Without the benefit of a specialist report, we cannot comment as to the condition or standard of the installation.

Parts of the installation are dated. As such, we consider that a NICEIC qualified engineer should carry out a functional test and advise on any upgrading works for obvious safety reasons unless the installation has been examined and tested within the last five years.

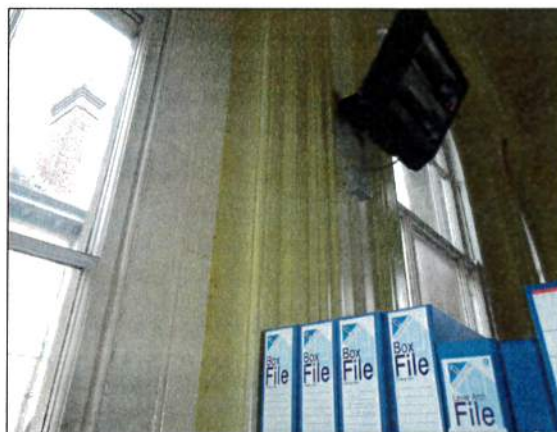
There are electric wall and panel heaters serving the main upper level accommodation. If these have not been tested within the last five years, then we would recommend that the heaters are also inspected by a NICEIC qualified engineer and all recommendations implemented.

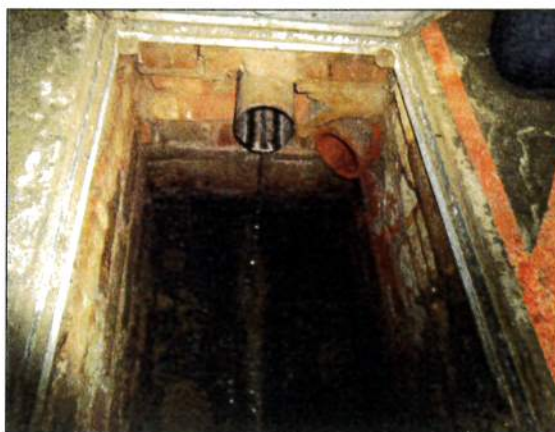
The foul drain was found to be free from chokage with no problems apparent.

We assume that the property drains to a mains sewer in Fore Street to the east. This point should be confirmed.
