PLAY AREA SAFETY INSPECTION REPORT

Liskeard Town Council

11 April 2017

Site Owner : **Liskeard Town Council**
Site Name : Liskeard TC - Rapsons Field Skatepark
Date of Inspection : 11 April 2017
Inspected by : Steve Langsford

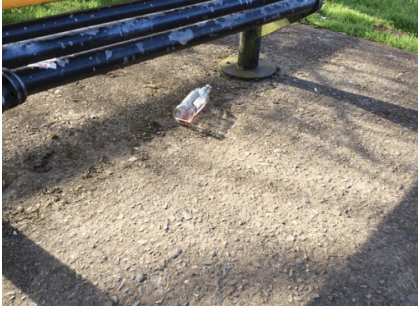
ANCILLARY ITEMS

Item	Type	Comments, action or control required	Risk Level	Risk Score†
Facilities				
Litter Bins Risk Score : 3 Risk Level : Very Low	Bins	Satisfactory  		
Youth Shelter Risk Score : 5 Risk Level : Low	Shelter	Satisfactory  		
Horticulture				
Planting Risk Score : 4 Risk Level : Low	Borders	Satisfactory		
Perimeter				
Fencing Risk Score : 3 Risk Level : Very Low	Fencing	Finding : Fence - Section Missing   Notes : Close board fence sections missing / damaged. Task : Replace missing section of fence	Low	6

<p>Gates</p> <p>Risk Score : 3 Risk Level : Very Low</p>	<p>Entrance</p>	<p>Finding : Entrapment on side(s) of gate</p>   <p>Task : Adjust gate/posts/fit new rubber buffer to ensure a spacing of at least 12mm throughout the range of the gate to remove the entrapment. The 12 mm gap also should apply on the hinge side of the gate</p>	<p>Low</p>	<p>6</p>
Site				
<p>Sign - EN 14974</p> <p>Risk Score : 2 Risk Level : Very Low</p>	<p>Signage</p>	<p>Satisfactory</p>  		
<p>Signage - Info / Operator</p> <p>Risk Score : 2 Risk Level : Very Low</p>	<p>Signage</p>	<p>Satisfactory</p>  		
Surface				
<p>General Surface</p> <p>Risk Score : 4 Risk Level : Low</p>	<p>General Surface</p>	<p>Finding : Site - Glass & litter</p> <p>Finding Date : 11/04/2017</p>	<p>Medium</p>	<p>8</p>

Task : Remove				
The overall risk for the ancillary items at the time of inspection:			Medium	8

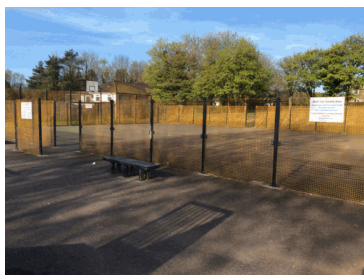
Multi-Use Games Area

Risk Level : Low
Risk Score : 7

The item meets with the requirements of the relevant standard where this may be tested on site without dismantling or destruction.

The surface meets with the requirements of the relevant standard where this may be tested on site without dismantling or destruction.

Comments, action or control required		Risk Level	Risk Score ‡
Equipment			
Finding :	Life expectancy is over 10 years depending upon volume of users and level of vandalism	Very Low	1
Task :	Monitor		
Surfacing - Tarmac			
No remedial maintenance work is required at this time.			
The overall risk for this item at the time of inspection:		Low	7
‡ For Risk Score see Report Notes

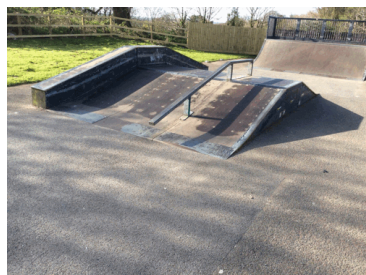
Skate - Driveway

Risk Level : **High**

Risk Score : **13**

The item meets with the requirements of the relevant standard where this may be tested on site without dismantling or destruction.

The surface meets with the requirements of the relevant standard where this may be tested on site without dismantling or destruction.

Comments, action or control required		Risk Level	Risk Score ‡
Equipment			
Finding :	Life expectancy is over 10 years depending upon volume of users and level of vandalism	Very Low	1
Task :	Monitor		
Surfacing - Tarmac			
No remedial maintenance work is required at this time.			
The overall risk for this item at the time of inspection:		High	13
‡ For Risk Score see Report Notes

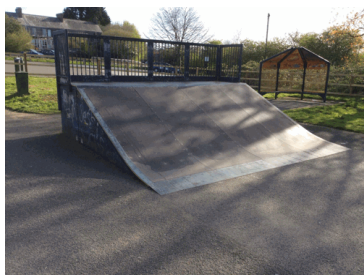
Skate - Flat Bank

Risk Level : **High**

Risk Score : **13**

The item meets with the requirements of the relevant standard where this may be tested on site without dismantling or destruction.

The surface meets with the requirements of the relevant standard where this may be tested on site without dismantling or destruction.

Comments, action or control required		Risk Level	Risk Score ‡
Equipment			
Finding :	The height of barriers shall be at least 1200mm and shall be reached at a maximum distance of 200mm from the front of the barrier	Low	6
Task :	No action given the risk assessment		
Finding :	Life expectancy is over 10 years depending upon volume of users and level of vandalism	Very Low	1
Task :	Monitor		
Surfacing - Tarmac			
No remedial maintenance work is required at this time.			
The overall risk for this item at the time of inspection:		High	13
‡ For Risk Score see Report Notes

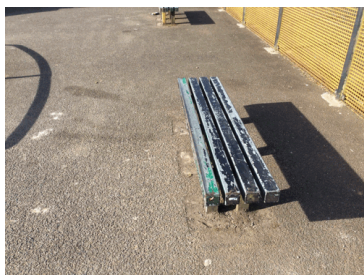
Skate - Grind Benches

Risk Level : **High**
Risk Score : **13**

The item meets with the requirements of the relevant standard where this may be tested on site without dismantling or destruction.

The surface meets with the requirements of the relevant standard where this may be tested on site without dismantling or destruction.

Comments, action or control required		Risk Level	Risk Score ‡
Equipment	No remedial maintenance work is required at this time.		
Surfacing - Tarmac	No remedial maintenance work is required at this time.		
The overall risk for this item at the time of inspection: ‡ For Risk Score see Report Notes		High	13

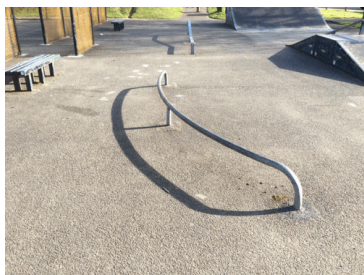
Skate - Grind Rails

Risk Level : Low

Risk Score : 7

The item meets with the requirements of the relevant standard where this may be tested on site without dismantling or destruction.

The surface meets with the requirements of the relevant standard where this may be tested on site without dismantling or destruction.

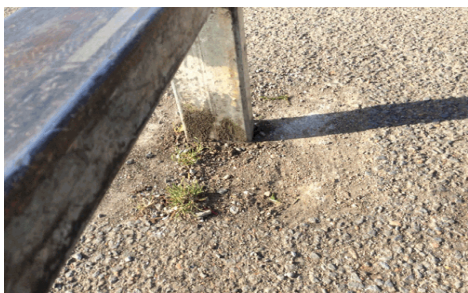
Recommended Maintenance and Risk Assessment Evaluation		Risk Level	Risk Score ‡
Equipment			
Finding :	Item - Loose in Ground	Low	6
Finding Date :	11/04/2017		
Notes :	Box section grind rail lower end loose in ground.

Task :	Secure and make stable main frame and supports		
Finding :	Life expectancy is over 10 years depending upon volume of users and level of vandalism	Very Low	1
Task :	Monitor		
Surfacing - Tarmac			
No remedial maintenance work is required at this time.			
The overall risk for this item at the time of inspection:		Low	7
‡ For Risk Score see Report Notes

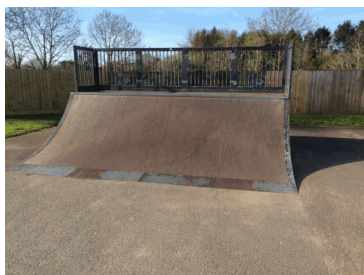
Skate - Quarter Pipe

Risk Level : **High**

Risk Score : **13**

The item meets with the requirements of the relevant standard where this may be tested on site without dismantling or destruction.

The surface meets with the requirements of the relevant standard where this may be tested on site without dismantling or destruction.

Comments, action or control required		Risk Level	Risk Score ‡
Equipment			
Finding :	Life expectancy is over 10 years depending upon volume of users and level of vandalism	Very Low	1
Task :	Monitor		
Finding :	The height of barriers shall be at least 1200mm and shall be reached at a maximum distance of 200mm from the front of the barrier	Low	6
Task :	No action given the risk assessment		
Surfacing - Tarmac			
No remedial maintenance work is required at this time.			
The overall risk for this item at the time of inspection:		High	13
‡ For Risk Score see Report Notes
