# PLAY AREA SAFETY INSPECTION REPORT

Liskeard Town Council

11 April 2017

Site Owner : **Liskeard Town Council**  
Site Name : Liskeard TC - Thorn Park  
Date of Inspection : 11 April 2017  
Inspected by : Steve Langsford

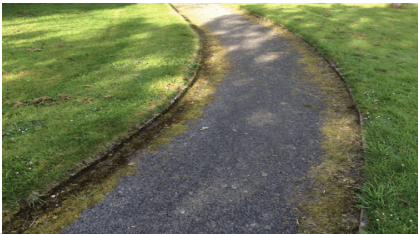
Pathways - Internal  Risk Score : 4 Risk Level : Low	Internal Paths	Satisfactory

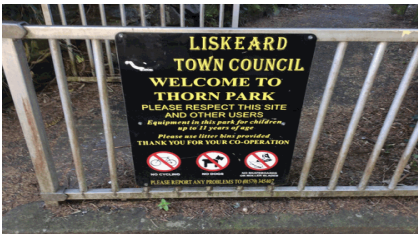
Signage - Info / Operator  Risk Score : 2 Risk Level : Very Low	Signage	Satisfactory

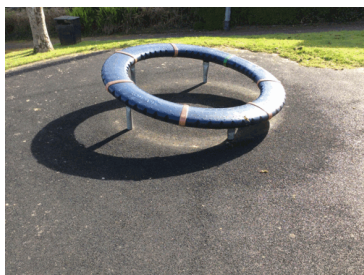
## Carousel - Supernova

Risk Level : Low

Risk Score : 7

The item meets with the requirements of the relevant standard where this may be tested on site without dismantling or destruction.

The surface meets with the requirements of the relevant standard where this may be tested on site without dismantling or destruction.

Comments, action or control required		Risk Level	Risk Score ‡
<b>Equipment</b>			
Finding :	Life expectancy is over 10 years depending upon volume of users and level of vandalism	Very Low	1
Task :	Monitor		
<b>Surfacing - Wet Pour</b>			
No remedial maintenance work is required at this time.			
<b>The overall risk for this item at the time of inspection:</b>		Low	7
‡ For Risk Score see Report Notes

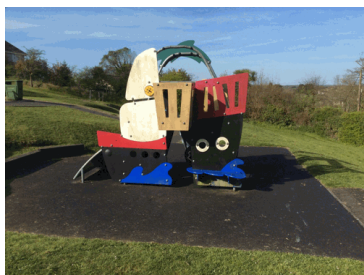
## Multiplay

Risk Level : Low

Risk Score : 6

The item meets with the requirements of the relevant standard where this may be tested on site without dismantling or destruction.

The surface meets with the requirements of the relevant standard where this may be tested on site without dismantling or destruction.

Comments, action or control required		Risk Level	Risk Score ‡
<b>Equipment</b>			
Finding :	Life expectancy is over 10 years depending upon volume of users and level of vandalism	Very Low	1
Task :	Monitor		
Finding :	There is offensive graffiti on the unit.	Low	6
Task :	Remove graffiti		
<b>Surfacing - Wet Pour</b>			
No remedial maintenance work is required at this time.			
<b>The overall risk for this item at the time of inspection:</b>		Low	6
‡ For Risk Score see Report Notes

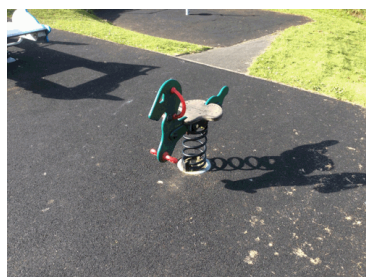
## Rocker - Dog

Risk Level : Low

Risk Score : 4

The item meets with the requirements of the relevant standard where this may be tested on site without dismantling or destruction.

The surface meets with the requirements of the relevant standard where this may be tested on site without dismantling or destruction.

Comments, action or control required		Risk Level	Risk Score ‡
<b>Equipment</b>			
Finding :	Life expectancy is over 10 years depending upon volume of users and level of vandalism	Very Low	1
Task :	Monitor		
<b>Surfacing - Wet Pour</b>			
No remedial maintenance work is required at this time.			
<b>The overall risk for this item at the time of inspection:</b>		Low	4
‡ For Risk Score see Report Notes

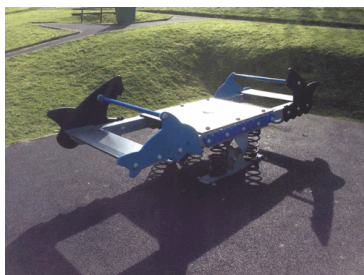
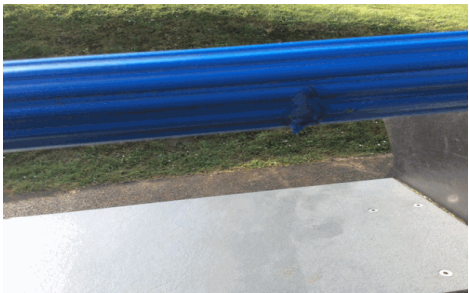
## Rocker - Seesaw

Risk Level : Low

Risk Score : 6

The item meets with the requirements of the relevant standard where this may be tested on site without dismantling or destruction.

The surface meets with the requirements of the relevant standard where this may be tested on site without dismantling or destruction.

Comments, action or control required		Risk Level	Risk Score ‡
<b>Equipment</b>			
Finding :	Life expectancy is over 10 years depending upon volume of users and level of vandalism	Very Low	1
Task :	Monitor		
Finding :	Item - Vandalised (arson)	Low	7
Finding Date :	11/04/2017		
Notes :	Hand bars have been melted in a couple of places leaving rough edges - smooth down.

Task :	Repair item		
<b>Surfacing - Wet Pour</b>			
No remedial maintenance work is required at this time.			
The overall risk for this item at the time of inspection:		Low	7
‡ For Risk Score see Report Notes

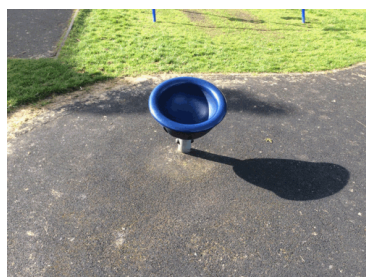
## Rotator - Bowl

Risk Level : Low

Risk Score : 6

The item meets with the requirements of the relevant standard where this may be tested on site without dismantling or destruction.

The surface meets with the requirements of the relevant standard where this may be tested on site without dismantling or destruction.

Comments, action or control required		Risk Level	Risk Score ‡
<b>Equipment</b>			
Finding :	Life expectancy is over 10 years depending upon volume of users and level of vandalism	Very Low	1
Task :	Monitor		
<b>Surfacing - Wet Pour</b>			
No remedial maintenance work is required at this time.			
<b>The overall risk for this item at the time of inspection:</b>		Low	6
‡ For Risk Score see Report Notes

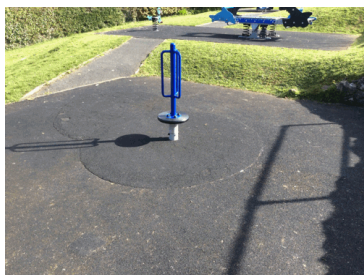
## Rotator - Turnstile

Risk Level : Low

Risk Score : 6

The item meets with the requirements of the relevant standard where this may be tested on site without dismantling or destruction.

The surface meets with the requirements of the relevant standard where this may be tested on site without dismantling or destruction.

Comments, action or control required		Risk Level	Risk Score ‡
<b>Equipment</b>	No remedial maintenance work is required at this time.		
<b>Surfacing - Wet Pour</b>	No remedial maintenance work is required at this time.		
<b>The overall risk for this item at the time of inspection:</b> ‡ For Risk Score see Report Notes		Low	6

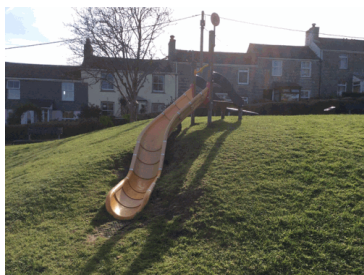
## Slide

Risk Level : Low

Risk Score : 6

The item meets with the requirements of the relevant standard where this may be tested on site without dismantling or destruction.

The surface meets with the requirements of the relevant standard where this may be tested on site without dismantling or destruction.

Comments, action or control required		Risk Level	Risk Score ‡
<b>Equipment</b>			
Finding :	Life expectancy is over 10 years depending upon volume of users and level of vandalism	Very Low	1
Task :	Monitor		
<b>Surfacing - Misc Grass Matting</b>			
Finding :	Trip zones at edge of surface	Medium	8
Notes :	Slide run-out matting lifting.		
Task :	Build up ground levels to remove trip hazard		
<b>The overall risk for this item at the time of inspection:</b>		Medium	8
‡ For Risk Score see Report Notes

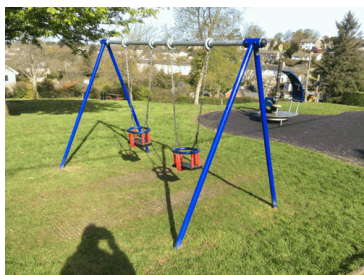
## Swing - Toddler - 1 Bay 2 Seat

Risk Level : Low

Risk Score : 4

The item meets with the requirements of the relevant standard where this may be tested on site without dismantling or destruction.

The surface meets with the requirements of the relevant standard where this may be tested on site without dismantling or destruction.

Comments, action or control required		Risk Level	Risk Score ‡
<b>Equipment</b>			
Finding :	Life expectancy is over 10 years depending upon volume of users and level of vandalism	Very Low	1
Task :	Monitor		
<b>Surfacing - Misc Grass Matting</b>			
No remedial maintenance work is required at this time.			
<b>The overall risk for this item at the time of inspection:</b>		Low	4
‡ For Risk Score see Report Notes
